Analysis and Recommendations for Street Network

Interlaken Town

August 2019

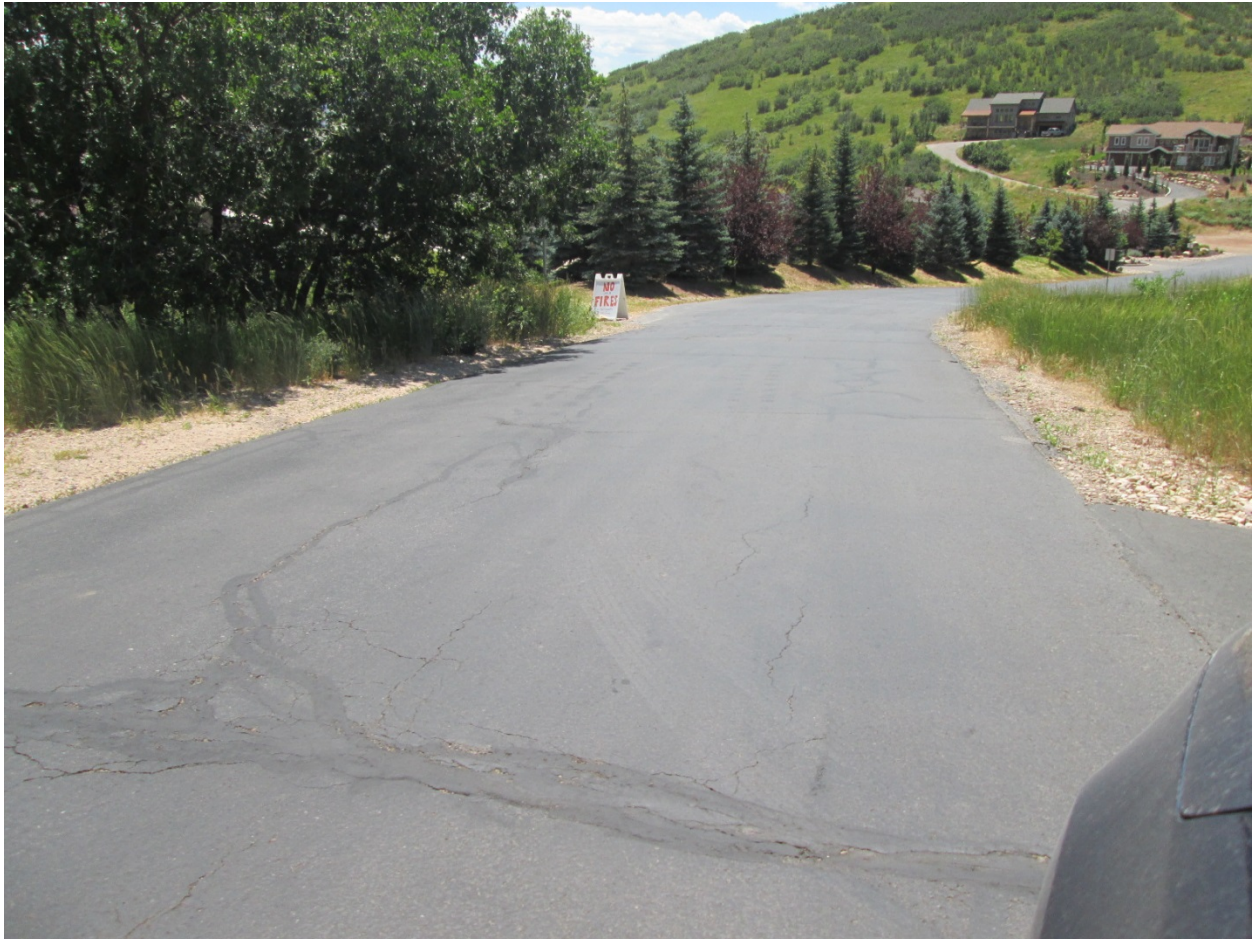
Photo 1. Fair Condition – Interlaken Dr from Interlaken Dr to Edelweiss Ln (RSL = 8 years)

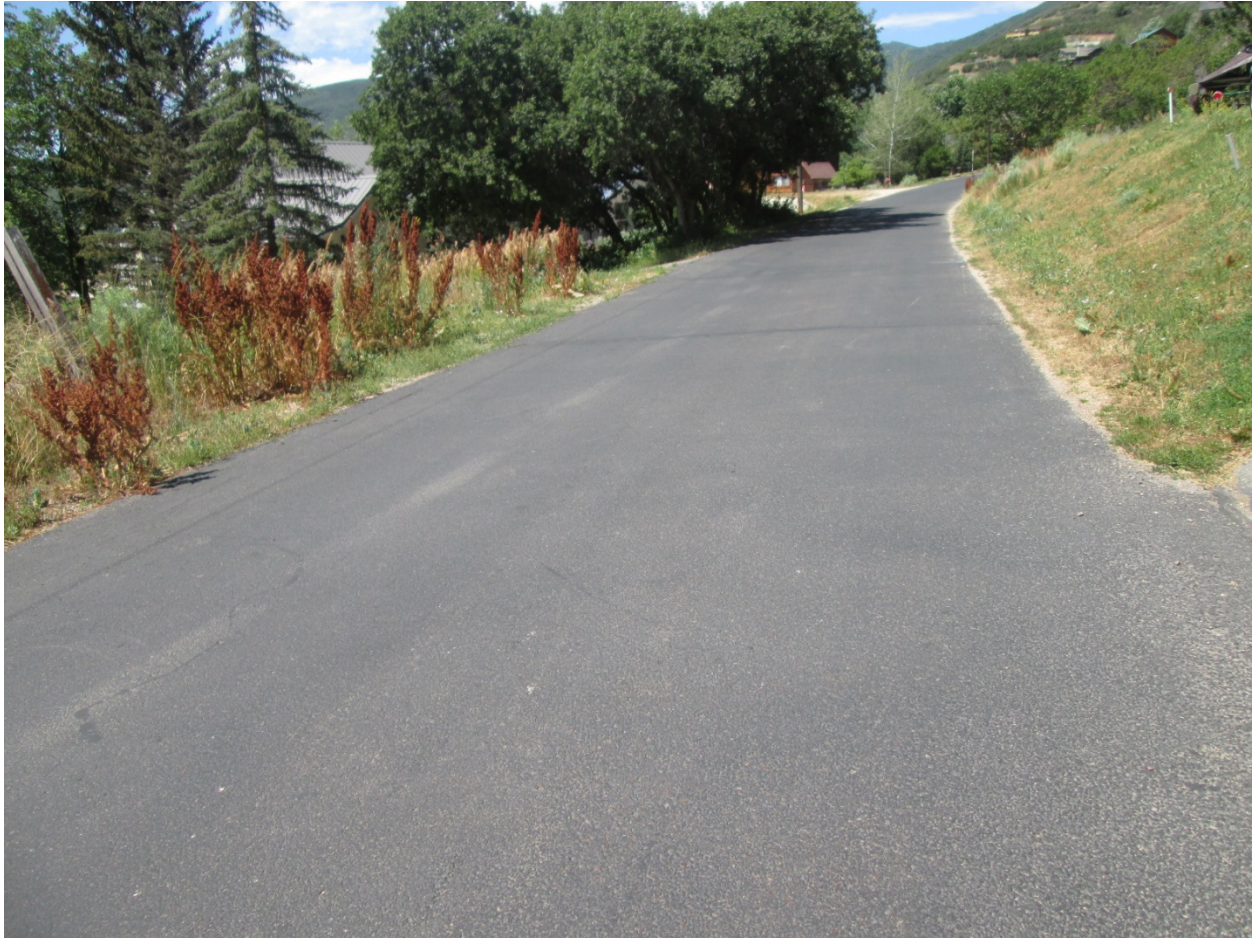
Photo 2. Good Condition – Interlaken Dr from Interlaken Dr to Luzern Rd (RSL = 10 years)

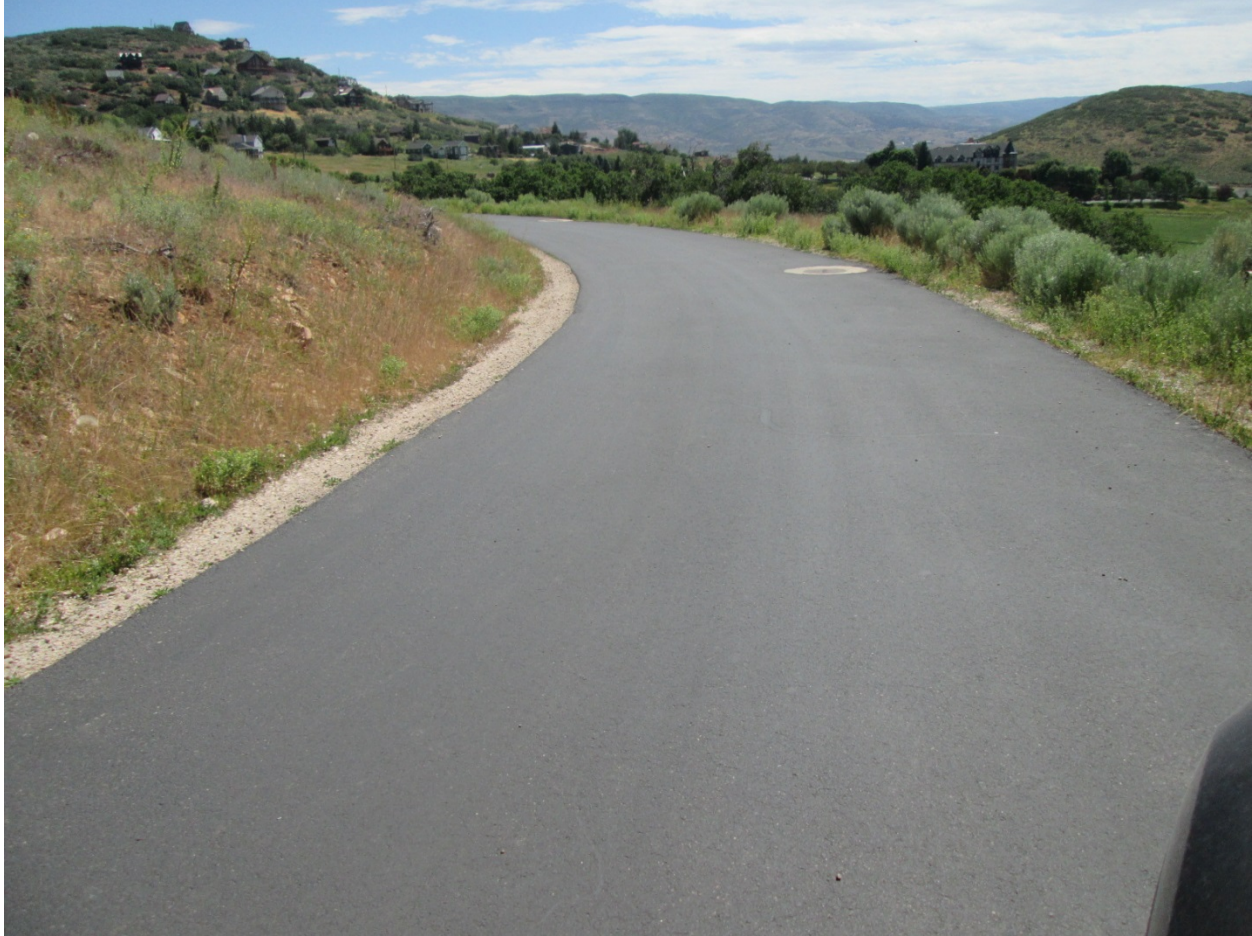
Photo 3. Very Good Condition – Luzern Rd from Luzern Rd to Luzern Rd (RSL = 14 years)
